Torque Converter Rebuilders Association

Getting to know the 68RFE

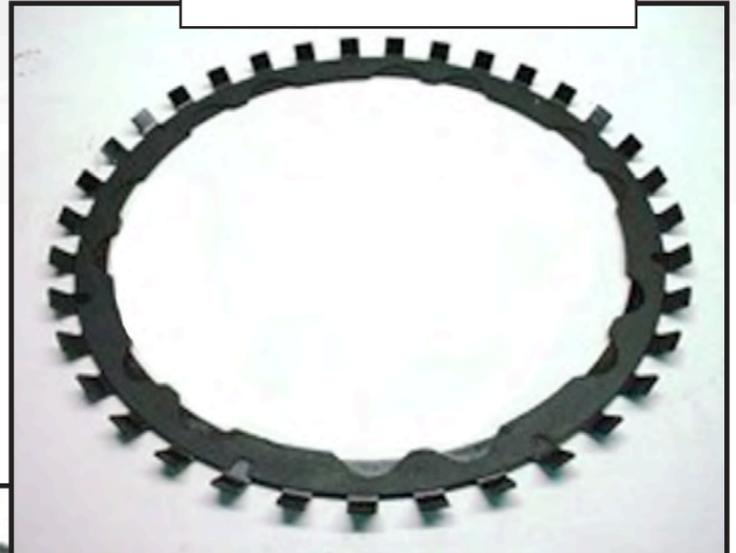
Dual Friction Clutch Plate

Also common to these units is friction failure on the dual friction clutch plate.
